Brooklyn Public Schools

Roof Budget and Recommendations for:

Brooklyn Elementary School

119 Gorman Road

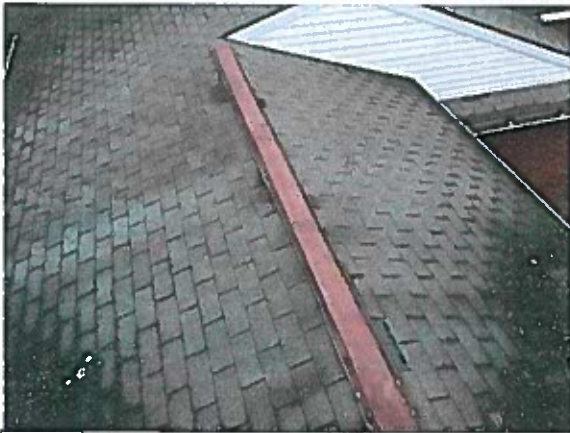
Photo #1: View of the shingled roofs

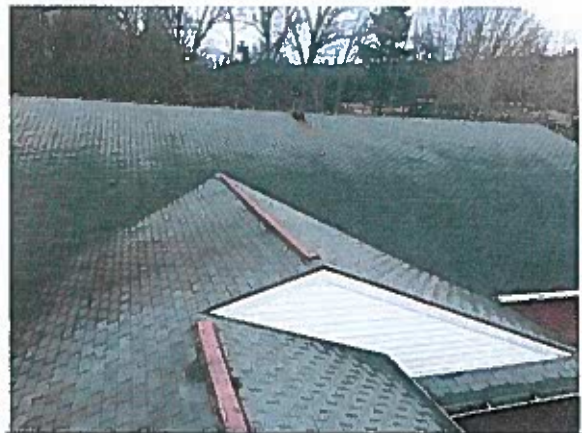
Photo #2: Another view of the shingled roofs

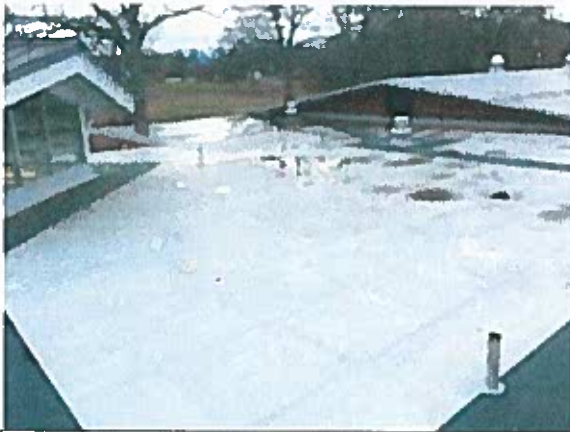
Photo #3: View of the PVC roofs facing South

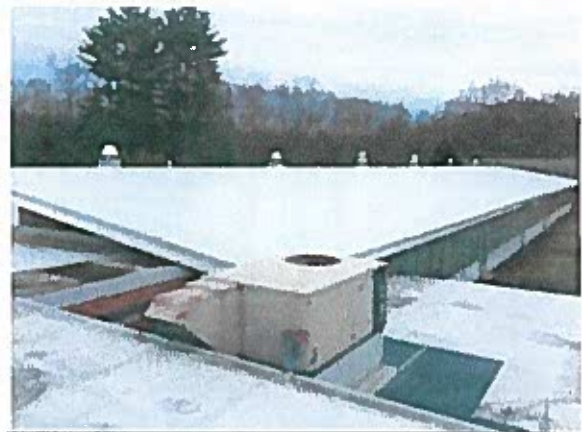
Photo #4: View of Roof K

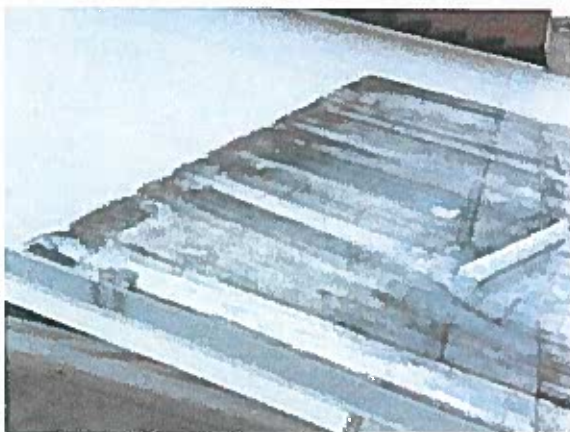
Photo #5: Membrane is dirty due to debris

- 1) Repairs all openings in flashings
- 2) Repair all open seams
- 3) Clear all debris

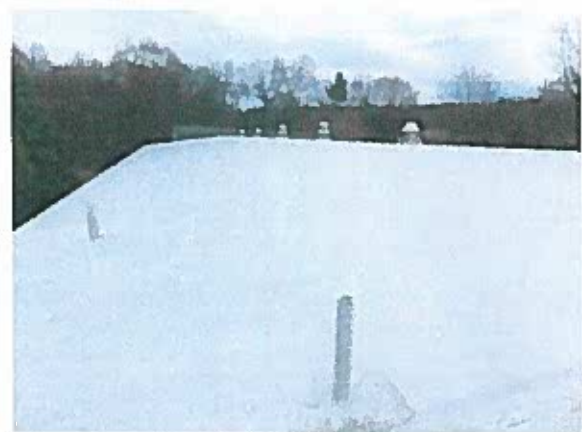
Photo #6: Another view of Roof K

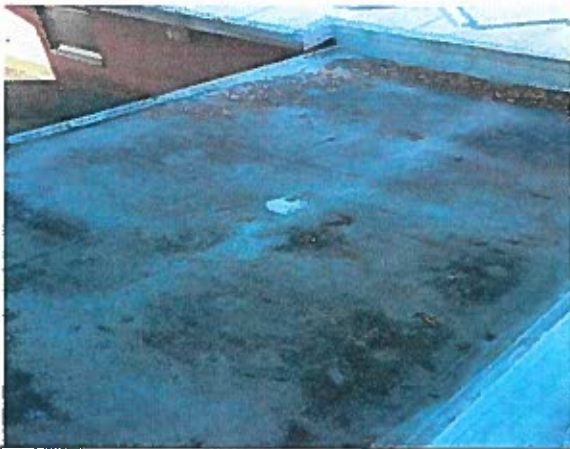
Photo #7: Lower roof section

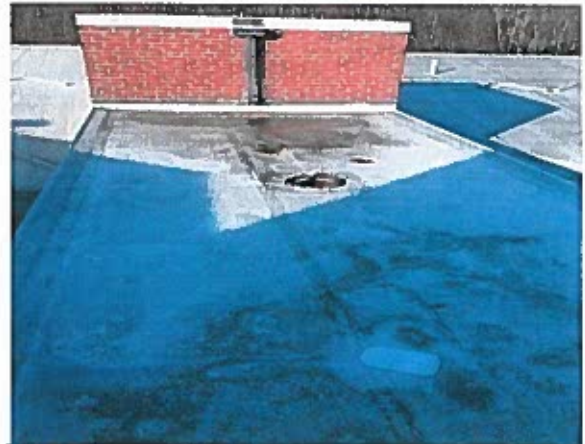
Photo #8: View of Roof B

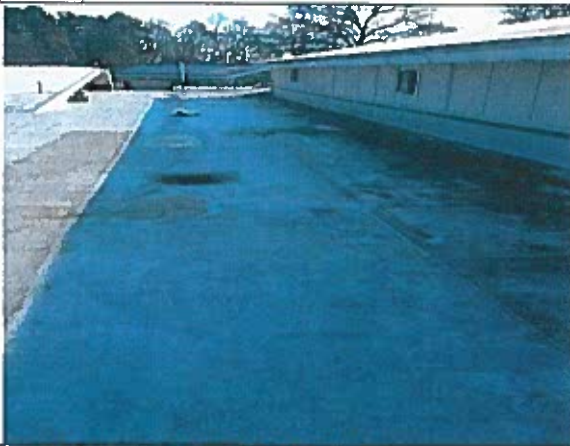
Photo #9: View of Roof E facing East

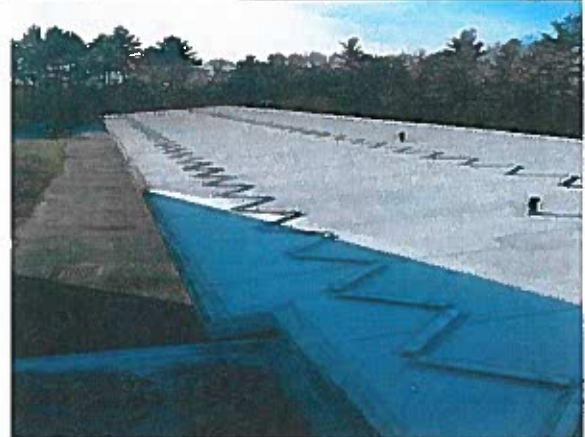
Photo #10: View of Roof A

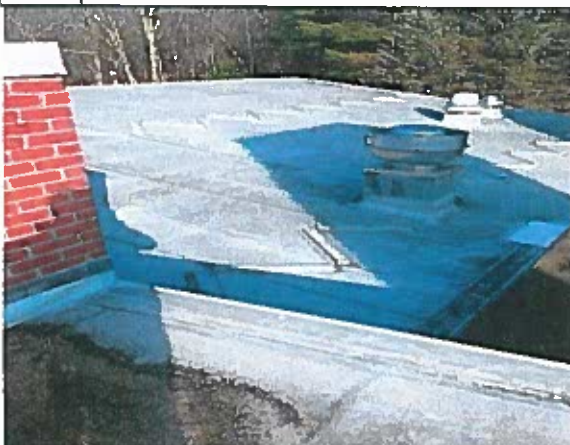
Photo #11: Another view of the North side Roof A

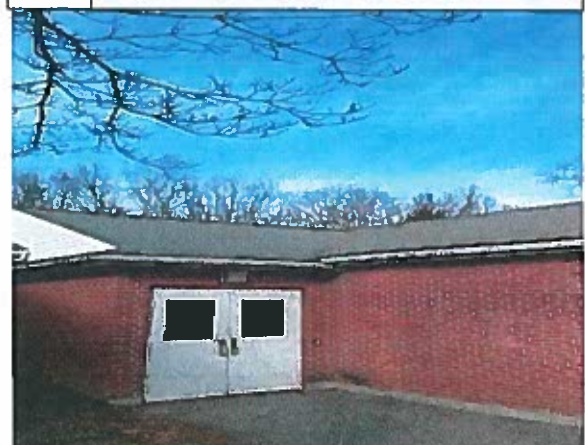
Photo #12: Another view of the Shingled roof from Ground level

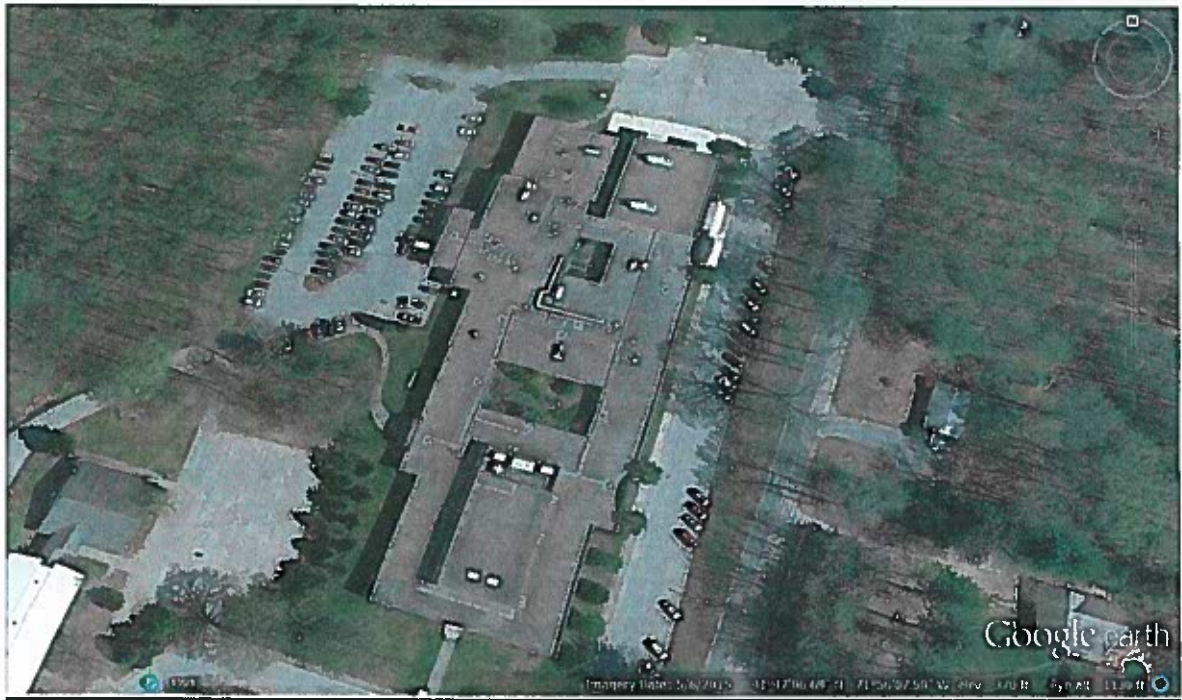
Brooklyn Middle School Roof Budget

Roof installed in 1995

Roof system consists of a built-up roof with gravel

Approximately 86,880 sq. ft.

Replacement budget \$2,172,000
