Email re: 117 Tatnic Road dated 4/16/21

4-16-21 Joe Szarkowicz photos re: 117 Tatnic Road

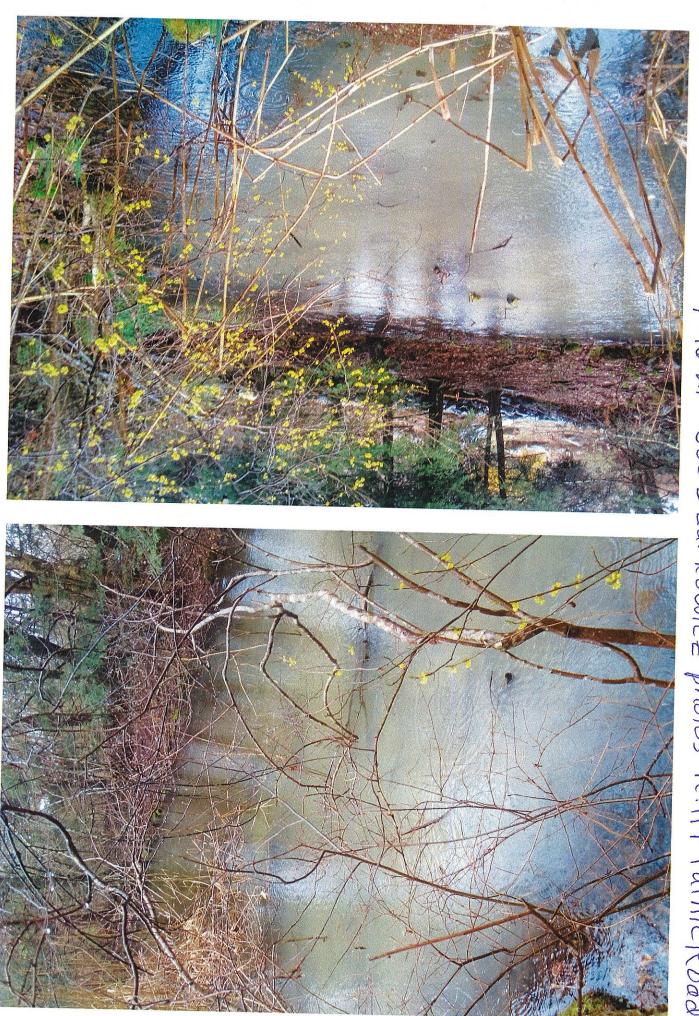
Attached a couple photos taken around 2:30 today - Friday 4/16. Considerable amount of sediment - I don't know if it is stone dust washing off of all the stone placed recently or still some silt coming through, or a combination of both. Have both grey and tan colors in there. Hope the next storm will prove to be better - I don't consider this one a pass yet.
